TechSmart® DISA Valve Repair Kits

F66001 / F66002 / F66003
BMW 2012-97
VIO over 1.5 Million

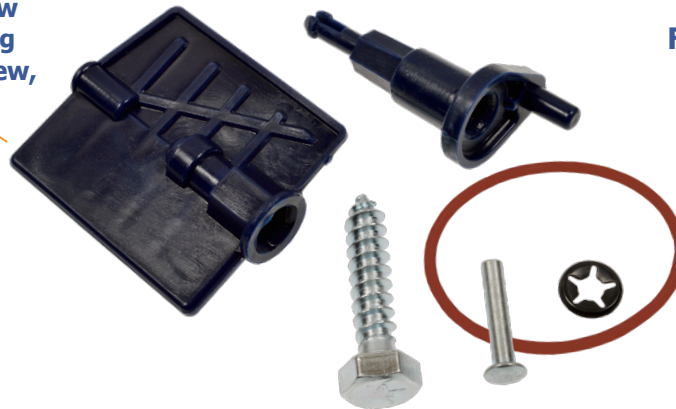
Comes complete with new flap, flap driver, mounting pin and clip, removal screw, and O-ring

Allows you to replace only failed flap instead of full DISA Valve assembly

Our Response: To save customers money, TechSmart's DISA Valve Repair Kits include everything needed to replace only the failed flap instead of the entire DISA valve assembly. Each kit comes complete with a new flap, a flap driver, a mounting pin and clip, a screw to assist with removing the damaged unit, and an O-ring to prevent vacuum leaks.

TechSmart® Tip: When installing a DISA valve that has new components, use caution and make sure the vacuum lines and electrical connector are connected. Also, clear stored memory if any trouble codes were stored or any drivability issues are noticed.
