QUALITY ADVANTAGE BLOWER MOTORS

Four Seasons® P/N 75777 & 75778 Unit

Four Seasons® 75850 Unit

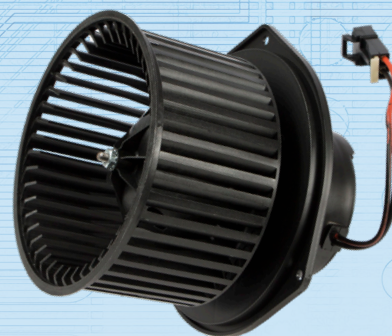
Four Seasons® provides a hassle free, drop-in-replacement design that does not require any kind of special installation kit. With the installer in mind, we designed a motor that would not only fit and perform as needed, but would also be easier to install, saving both time and money.

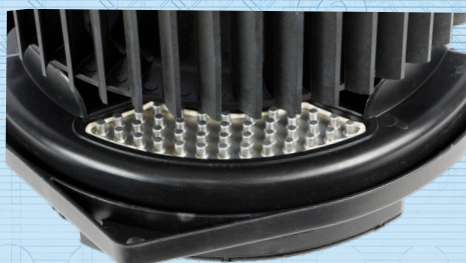
Integrated cooling tube for extended motor life
