« JUST THE FACTS »

Diesel Fuel Injection Pumps - Remanufactured

Our Multi-Step Process Ensures Quality

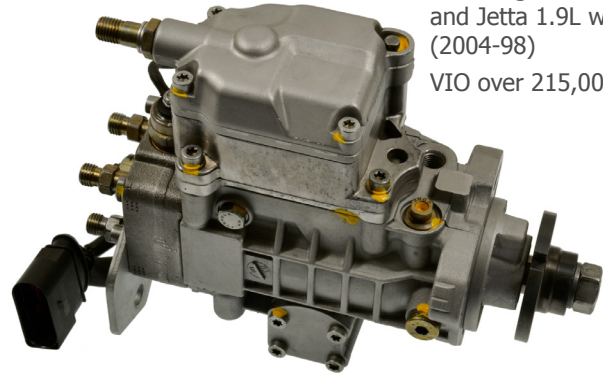
800-17548

Volkswagen Beetle, Golf, and Jetta 1.9L w/ AT (2004-98)

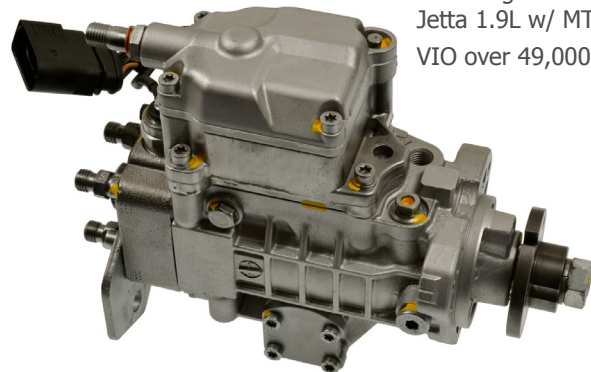
800-17549

Volkswagen Beetle, Golf, and Jetta 1.9L w/ MT (2004-98)

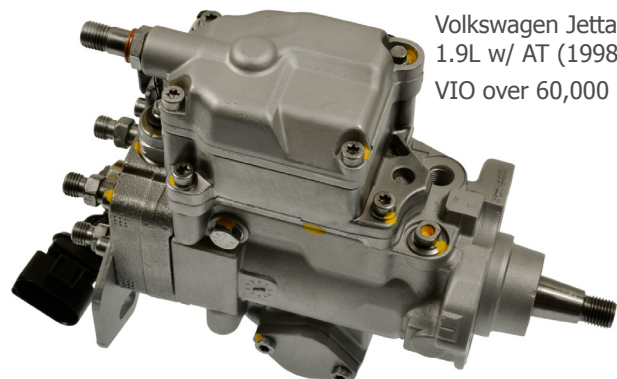
800-17550

Volkswagen Jetta and Passat 1.9L w/ AT (1998-96)
