# THINK TECHSMART® FIRST

## TechSmart® High Pressure Fuel Pump Cam Follower

TechSmart® now offers a high-quality direct replacement High Pressure Fuel Pump Cam Follower for 2013-2006 VW/Audi 2.0T.

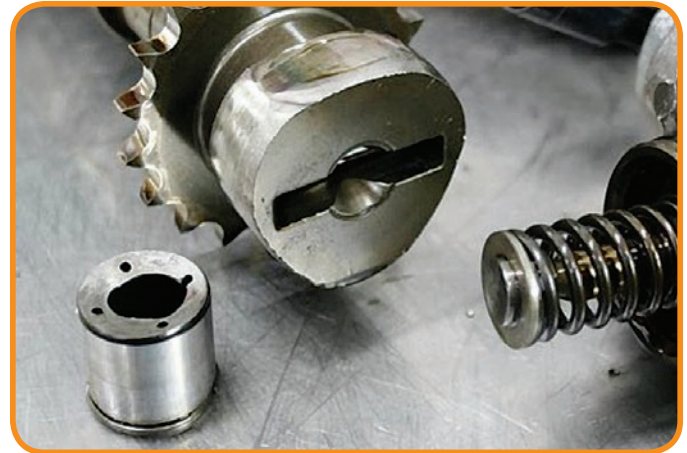
The low-friction coating on the original units can wear down over time causing excess friction against the cam lobe and high-pressure fuel pump plunger. This can lead to extreme engine damage and an expensive repair. Checking and replacing the cam follower with the TechSmart® T48001 will save money in the long run.

Catastrophic Failure

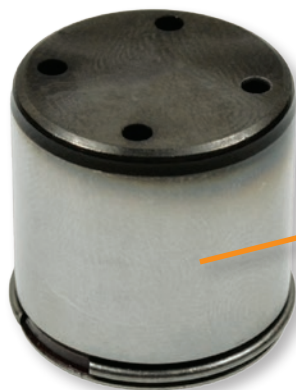
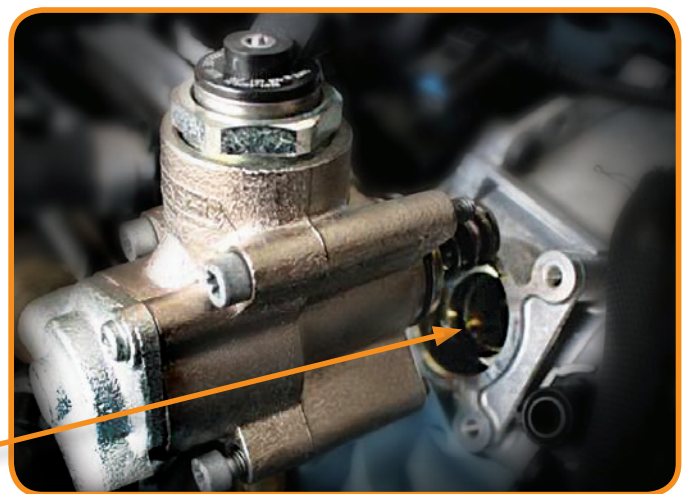
New  
TechSmart®  
T48001
